•Page 1 Flanged  
and Flued XJ  
replacement

## Replacement of Flanged and Flued Expansion Joints onto existing Heat Exchangers

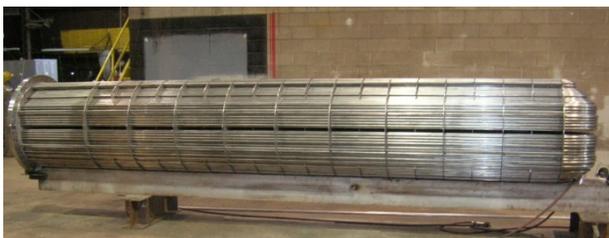
Stainless Steel "U" Bundle
